Round Rock Stagecoach Inn

Round Rock, Texas

Relocation Feasibility Study

December 5, 2016

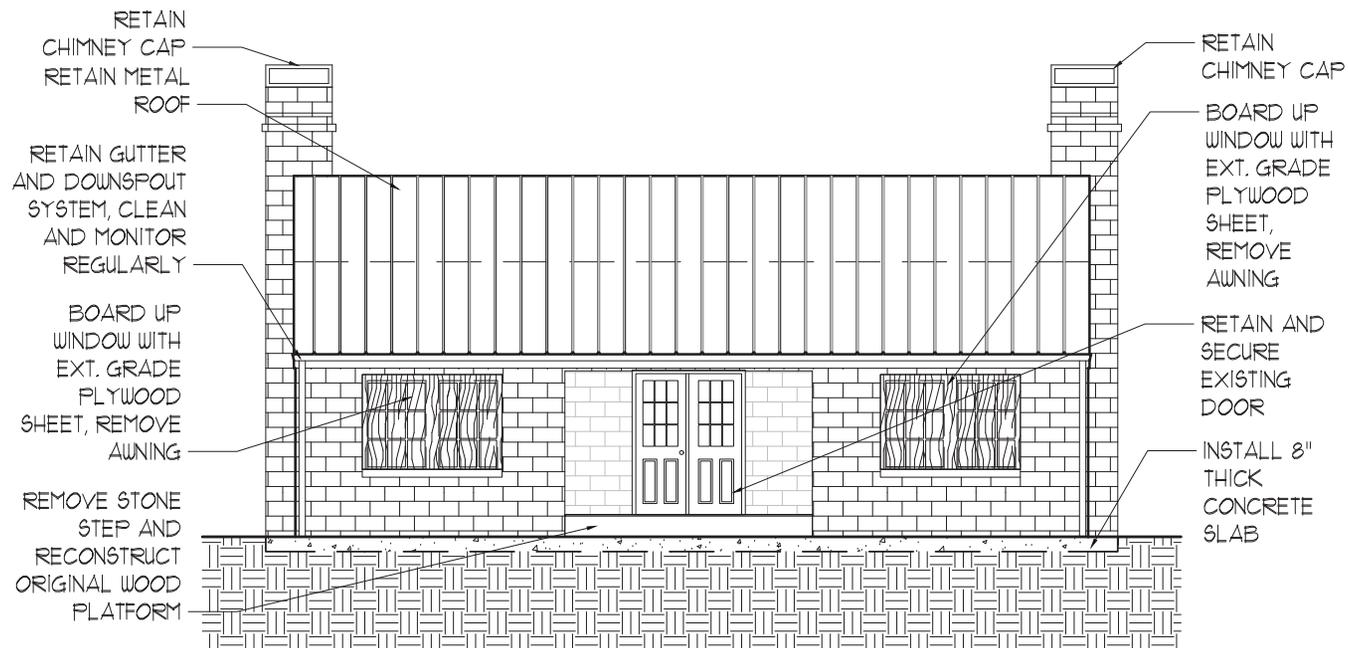
Stabilization of Historic East Elevation

Figure 20. Elevations for Stabilization/Mothballing of East Elevation, after relocation to new site
(Drawing by ARCHITEXAS, 2016)

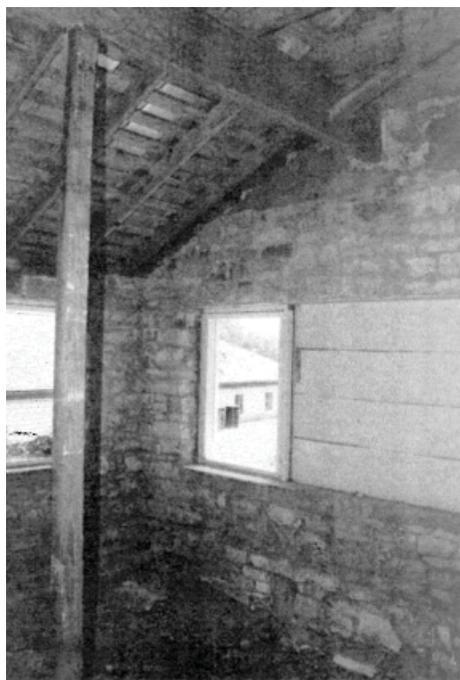
1990s Restoration showing roof construction
(Source: City of Round Rock)

The modern roof construction can be maintained during the move and after relocation. The building most likely originally had a pole and rafter roof construction. Historical documentation mentions beams made of hand-hewn oak. The historic roof construction is beyond the scope of this report and its reconstruction is depending on future programming needs and interpretation philosophies, as they are determined.

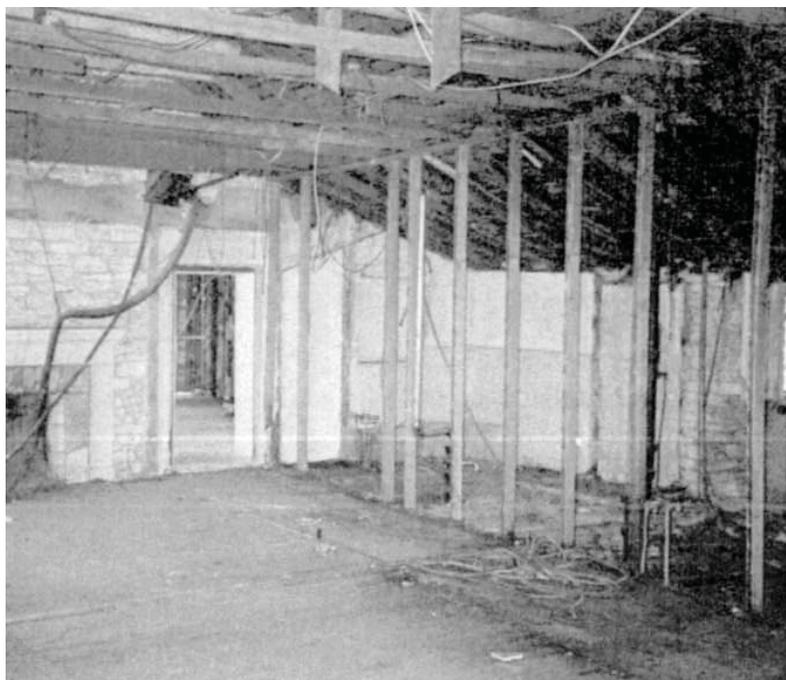
1990s Restoration showing roof construction
(Source: City of Round Rock)

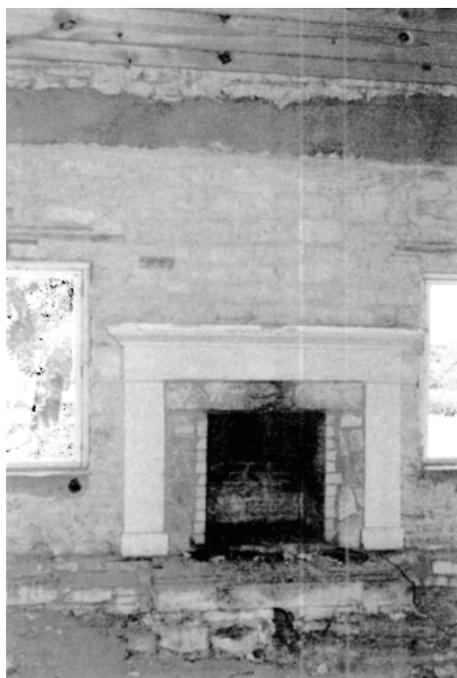
1990s Restoration showing removal of flooring
(Source: City of Round Rock)

During rehabilitation, cedar flooring should be installed throughout the interior.
