405 E. Main Street Certificate of Appropriateness HP25-007

Request: Replace damaged windows on garage with new wood windows. New windows will have an external wood grille instead of true divided lights

Date of Review: April 15, 2025

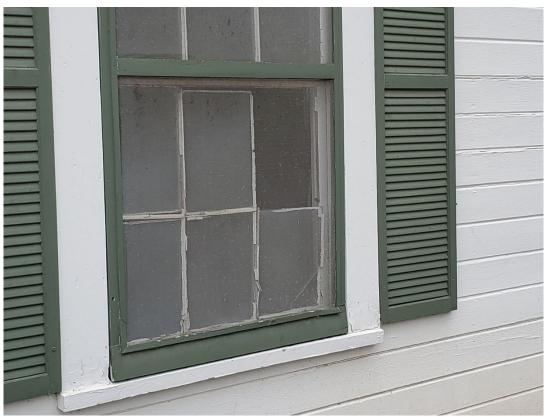
The three 6-over-6 wood windows have been damaged to the extent that repair is impractical. The applicant has not submitted sketches but provided the following description of proposed repairs:

Detail of damaged left window on east wall

Replace rotten wood and broken glass on three windows in the garage of the property. New sashes will be built to match the existing windows, new glass will be installed, and new grids will be attached to the exterior to match as closely as possible existing six lite grids. The window sashes will be painted to match other existing windows.

In discussion with staff, the applicant indicated that he proposes building the new wood sashes with a wood grille on the outside of the glass instead of muntins and true divided lights. The shape of the wood sashes and profile of the grilles will replicate the existing windows as closely as possible.
