207 N. Stone Street Certificate of Appropriateness HP25-006

Request: Replace water-damaged board-and-batten siding on garage. Garage would also be painted or stained.

Date of Review: April 15, 2025

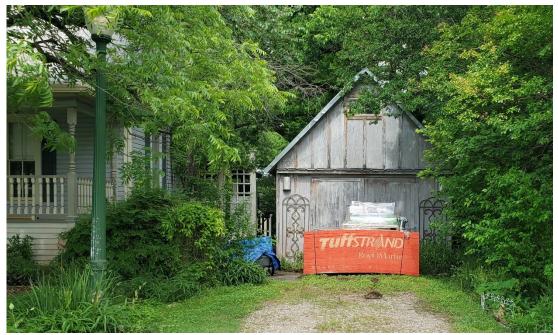
Garage to right of house, with a stack of OSB panels for an unrelated project in front of the doors

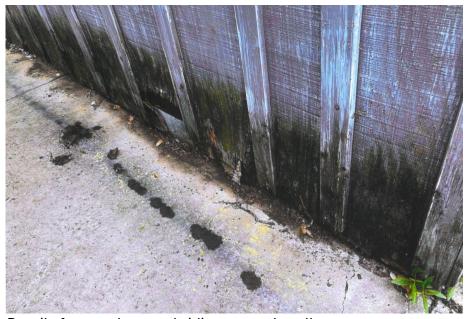
Water damage on the garage at the base of the north wall has been noted on the owner's tax exemption inspection report for several years. The applicant says that the damage started low and has extended upward over the years, so she expects the problem is the result of moisture wicked up from contact with the ground rather than rainwater splashing off the concrete. The damage is confined to the siding and the studs are unaffected.

Detail of water-damaged siding on north wall

The applicant proposes replacing the plywood sheathing on the entire wall. To prevent wicking, the sheathing would stop a few inches above ground and the gap would be covered by a horizontal plank of fiber cement siding. The vertical battens would stop at the fiber cement siding. Product information about the selected sheathing and fiber cement trim are included in the application. As an alternative, she is also considering using a plank of acetylated wood in place of the fiber cement board, depending on pricing and availability. Accoya | Acetylated Wood | Modified Wood | Treated wood

Standard for Rehabilitation #6 states that damaged historic features should be repaired of possible, and if not, the replacement will match the old in "design, color, texture and, where possible, materials." In this case the material substitution is warranted because the existing material is not sufficiently moisture-resistant for the location, and because the use of fiber cement does not detract from the historic structure, particularly if painted.

The selected Hardie Trim product has an embossed texture that is unlike the texture on the existing sheathing or battens. The HPC may wish to condition that the fiber cement plank have a smooth finish.

• The fiber cement plank shall have a smooth texture.

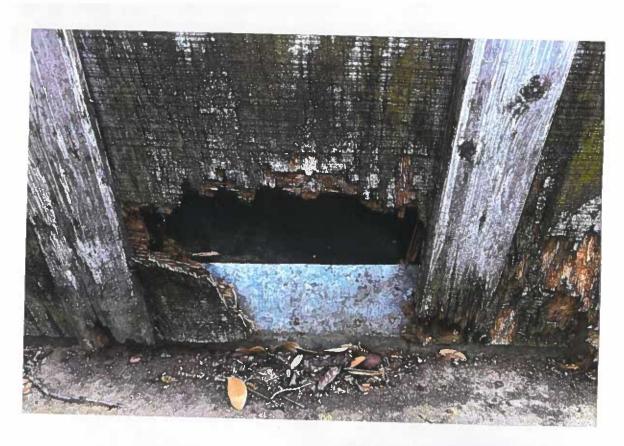
The Inside wall is not damaged
