## 607 E. Main Street Certificate of Appropriateness HP26-007

**Request:** This Certificate of Appropriateness (CofA) review involves recently completed alterations to the property including:

**Date of Review:** July 21, 2026

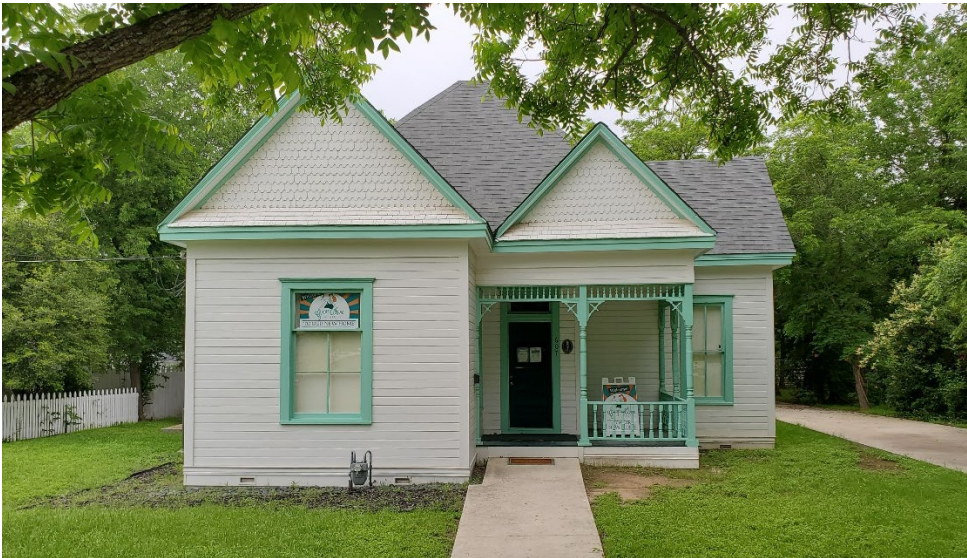
This house was built between 1896-1900 and is associated with the Black, Engstrand and Nelson families. Historic resource surveys describe the style as Queen Anne (2010 survey) and Folk Victorian (1992 survey). In the 2000s, the house began to fall into disrepair and was restored with a large rear addition between 2016-2019. The current owner purchased the house in 2022 to house her med spa business.

*May 2026 photo.*

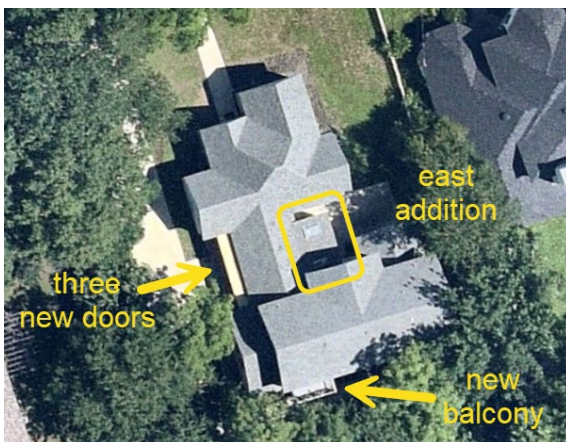
During the 2026 tax exemption inspection, staff noted significant alterations to the 2019 addition that had been made without a CofA, including:

*2026 aerial photo indicating locations of different parts of the project.*

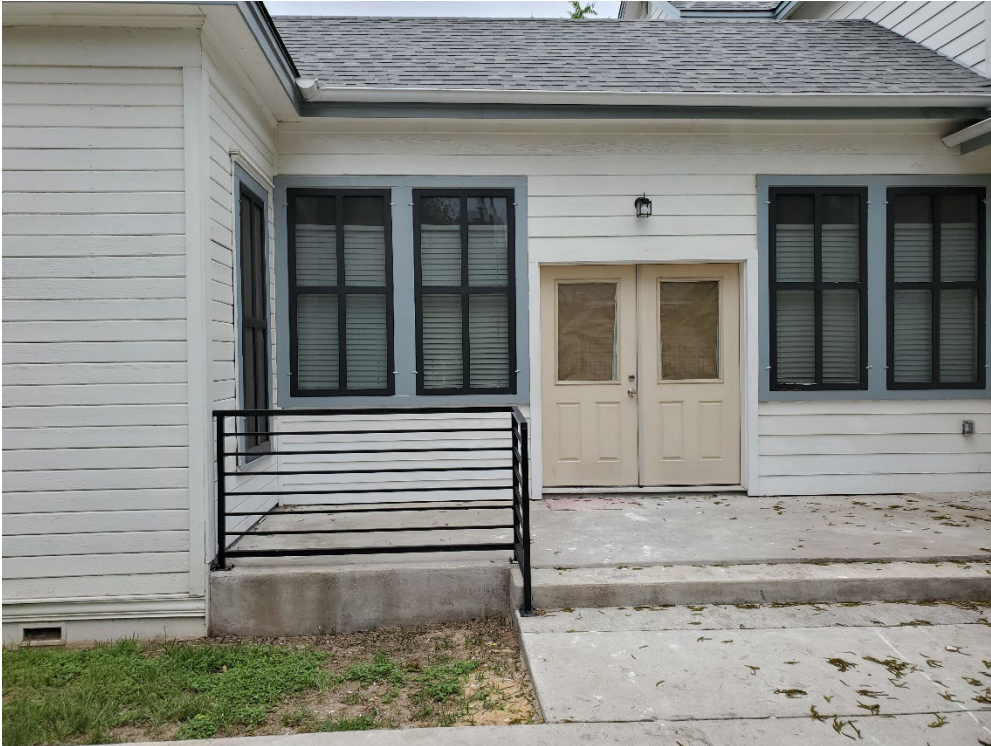
West (side) doors and windows:

*2023 photo showing the first set of screens*

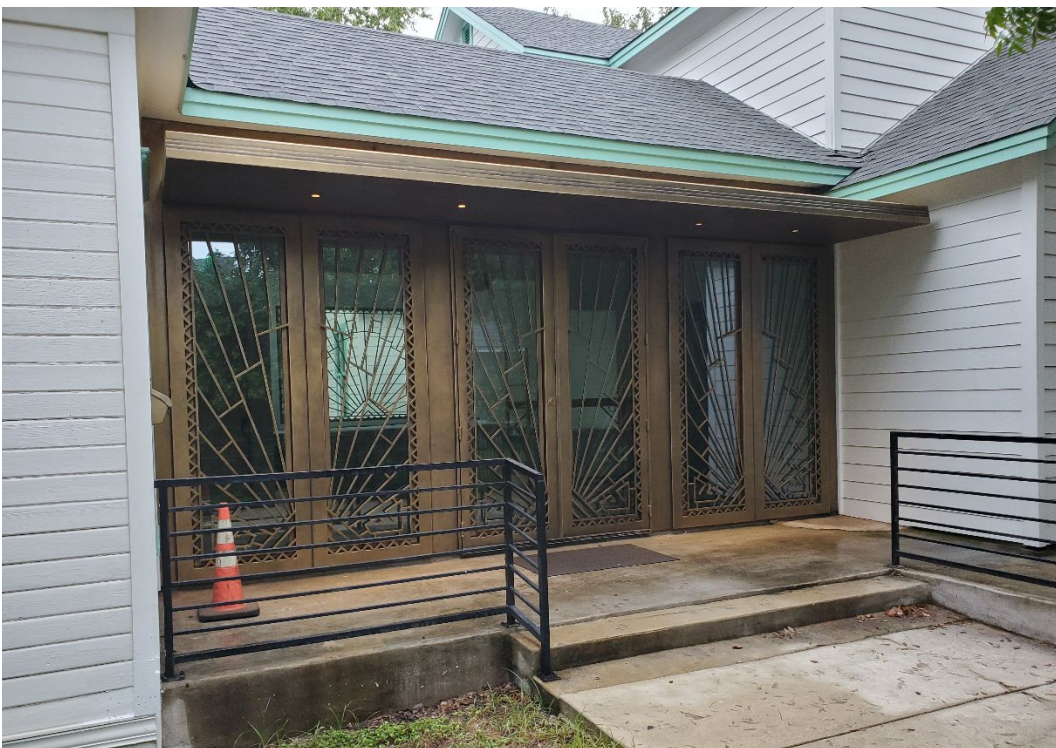
- The paired doors and windows on the west side had been removed and replaced with three paired doors with elaborate Art Deco style grilles. A shallow canopy had also been added under the eaves.

*June 2026, showing new doors and canopy.*

The west doors and windows were removed and replaced with three pairs of larger doors. A canopy with downlights was constructed to shelter the entry. The applicant made this change because she uses it as the primary entrance for her business.

The architect designing the 2019 addition connected it to the historic house through a narrow segment that formed a courtyard/patio on the east side and was more densely glazed than the rest of the addition. It was intended to clearly distinguish where the historic house ended and the addition began. The three glazed doors on the west side appear to be a slightly more modern take on this type of connector that is something that connects the historic house and addition but isn't part of either.

- Replacing one paired door and two pairs of windows on the west side with three pairs of doors is appropriate as a feature of the connector between the historic house and the 2019 addition.

- The canopy with downlights is not appropriate because it was constructed under the eave and is not integrated with the roof structure of the 2019 addition.

- The new doors on the west side are not appropriate for this structure. More compatible doors should have a much simpler design, without the graphic decoration of the grilles. They should either have features usually associated with traditional doors such as panels, muntins, and moldings, or should have a minimal design with one large pane of glazing. Appropriate doors should be painted or stained wood.

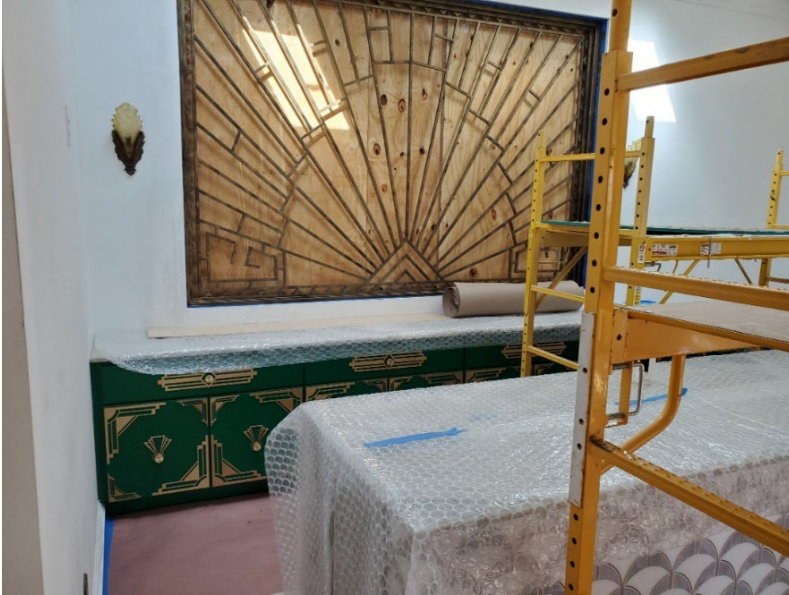
The wall opposite the three new doors was removed as part of a small addition into a patio area between the historic house and the 2019 addition. The four double-hung windows on the wall that was removed were replaced with one large horizontal fixed window on the east wall of the new addition.

*June 2026, during installation the east-facing window on the addition opposite the west doors. The east door is out of frame to the left. A wall with four double-hung windows was removed for this addition.*

A small addition with a new horizontal window was constructed on the east side of the room that connects the historic house and the addition. The four 2/2 double-hung windows on this wall were replaced with a door and one large, fixed window.

- The east-facing addition is appropriate because it is attached to the 2019 addition and is tucked behind the historic structure.
- The window on the east-facing addition is not appropriate for this building because it has an Art Deco-style grille and a horizontal orientation, while the house is a Queen Anne/Folk Victorian and all the windows have a strong vertical orientation. A more compatible window would not have a grille. Appropriate replacements would be either a set of windows with vertical proportions, or a single window divided into lites with vertical proportions. Please note that windows with simulated muntins must have a grille on the exterior of the window; grilles-between-the-glass are not appropriate.

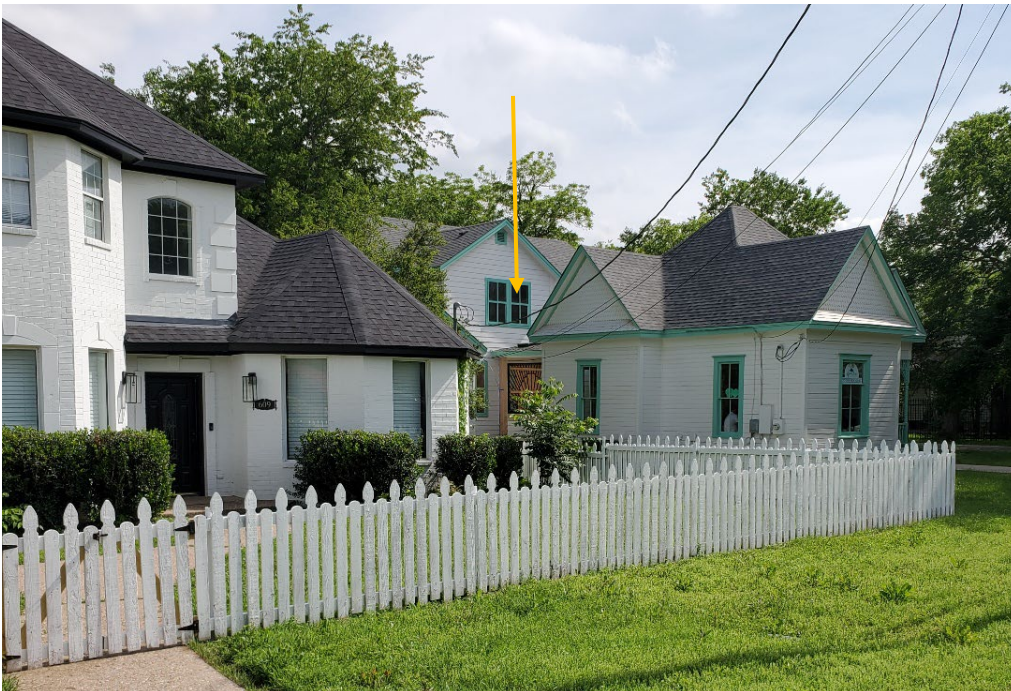
*Although the addition is tucked behind the historic part of the building, it is visible from the sidewalk.*

The part of the patio that was enclosed is tucked behind the historic part of the house and does not affect its historic integrity. Although the horizontal window contrasts with the double-hung windows on the rest of the house, it isn't particularly noticeable from outside.

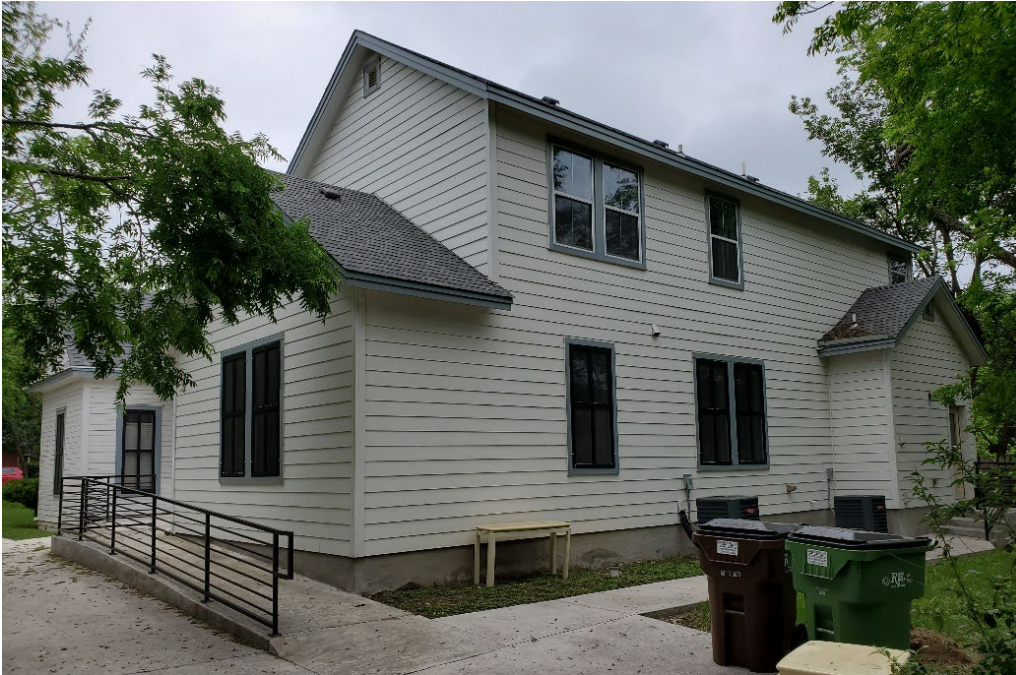
*2023 inspection photo. The older set of screens is in place.*

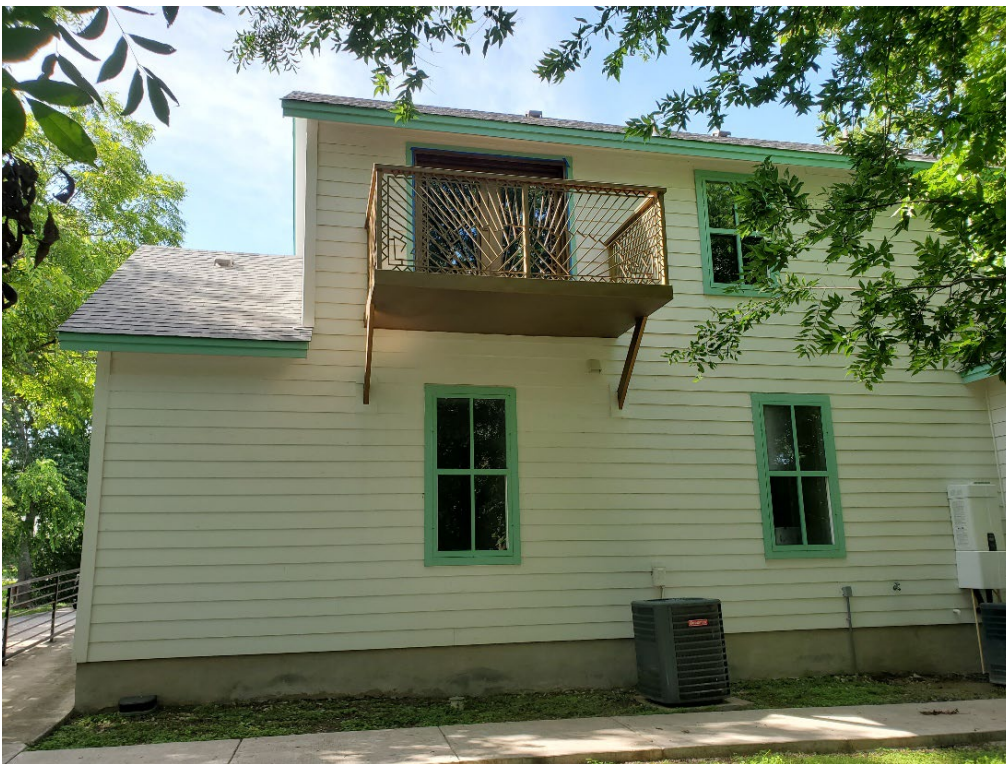
- A pair of double-hung windows on the second floor of the south (back) side had been replaced with a pair of doors with similar Art Deco grilles. A metal balcony had been added with similar Art Deco railing. On later investigation, it was discovered that the windows had been replaced with doors between the 2023 and 2024 inspections, and because the inspector was focused on the window screens the doors were overlooked.

*June 2026 photo of new balcony. The balcony doors have grilles similar to the west doors. Photo also shows the new, lighter-weight screens, and unscreened mechanical equipment.*

A balcony is common on Queen Anne style homes, though they are usually integrated with other details on the wall rather than placed on an otherwise flat wall, and they usually have wood railings. The new balcony also appears to project further out from the wall than would be common for a Queen Anne house, unless it were built over a first story bay window or other projection. Staff does not believe that this particular balcony is appropriate for this building, although a different design might be appropriate.

It was noted during this project review that the site includes unscreened mechanical equipment and trash receptacles. These should be screened in accordance with zoning district standards. A CofA is required to approve the material and design of required screening.

- The addition of a balcony to the south wall and conversion of the windows behind it to doors are appropriate for an addition to a historic Queen Anne-style house.

- The design of the balcony and doors are not appropriate on this structure. A more compatible balcony should have a much simpler wooden railing and would not be as deep. It should be embellished with elements such as wooden brackets, a roof, or moldings that relate to details on the addition.

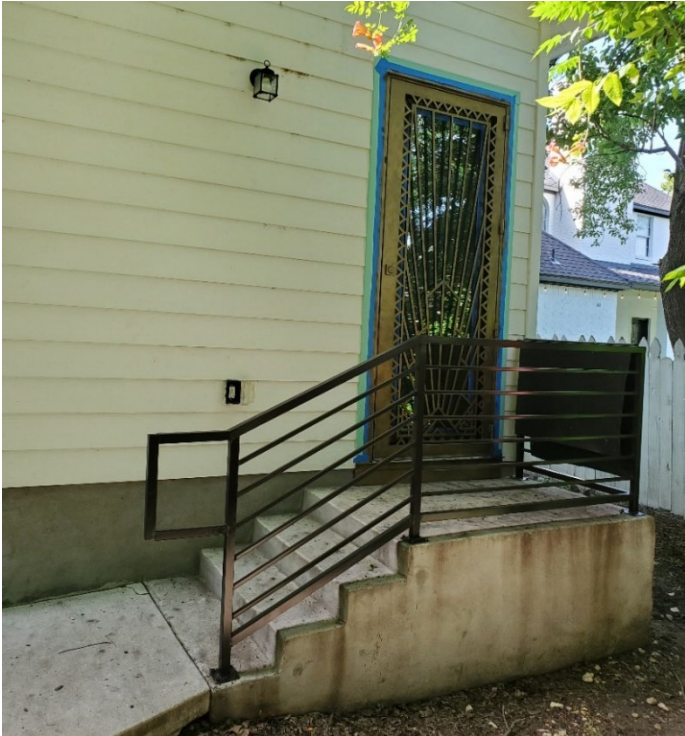
- A single door on the south side was replaced with a door with an Art Deco grille.

**South (back) door:**

*June 2026*
