## 607 E. Main Street Certificate of Appropriateness HP26-007

**Request:** This Certificate of Appropriateness (CofA) review involves recently completed alterations to the property including:

**Date of Review:** July 21, 2026

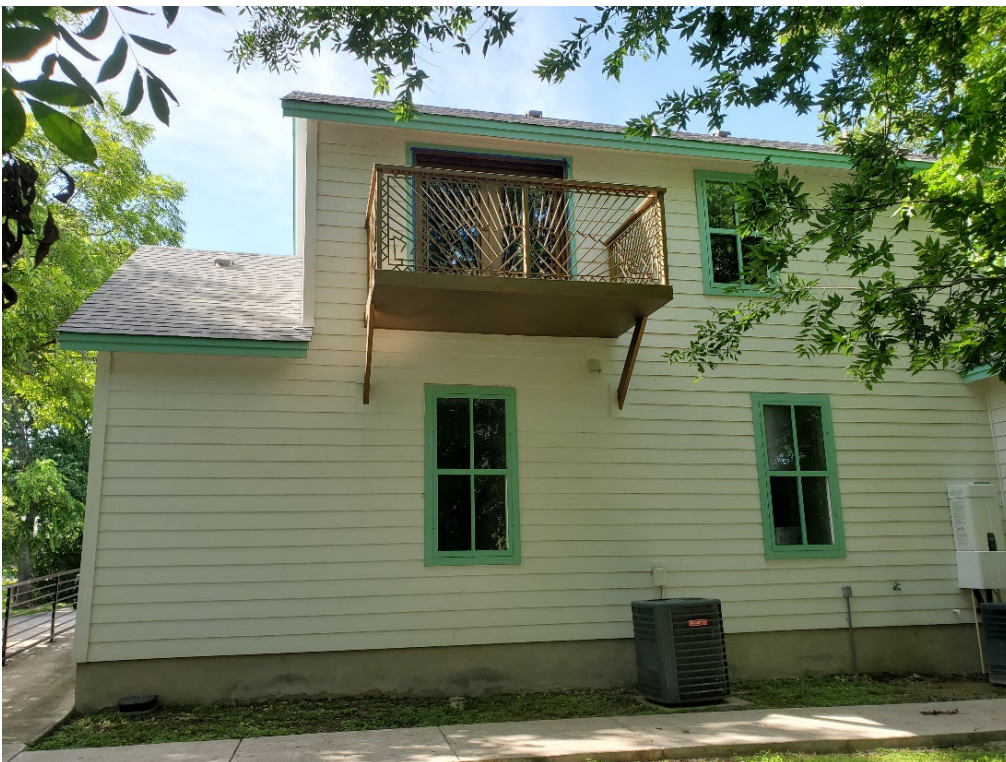
- A pair of double-hung windows on the second floor of the south (back) side had been replaced with a pair of doors with similar Art Deco grilles. A metal balcony had been added with similar Art Deco railing. On later investigation, it was discovered that the windows had been replaced with doors between the 2023 and 2024 inspections, and because the inspector was focused on the window screens the doors were overlooked.

*June 2026 photo of new balcony. The balcony doors have grilles similar to the west doors. Photo also shows the new, lighter-weight screens, and unscreened mechanical equipment.*

A balcony is common on Queen Anne style homes, though they are usually integrated with other details on the wall rather than placed on an otherwise flat wall, and they usually have wood railings. The new balcony also appears to project further out from the wall than would be common for a Queen Anne house, unless it were built over a first story bay window or other projection. Staff does not believe that this particular balcony is appropriate for this building, although a different design might be appropriate.

It was noted during this project review that the site includes unscreened mechanical equipment and trash receptacles. These should be screened in accordance with zoning district standards. A CofA is required to approve the material and design of required screening.

- The addition of a balcony to the south wall and conversion of the windows behind it to doors are appropriate for an addition to a historic Queen Anne-style house.

- The design of the balcony and doors are not appropriate on this structure. A more compatible balcony should have a much simpler wooden railing and would not be as deep. It should be embellished with elements such as wooden brackets, a roof, or moldings that relate to details on the addition.
