207 N. Stone Street Certificate of Appropriateness HP25-006

Request: Replace water-damaged board-and-batten siding on garage. Garage would also be painted or stained.

Date of Review: April 15, 2025

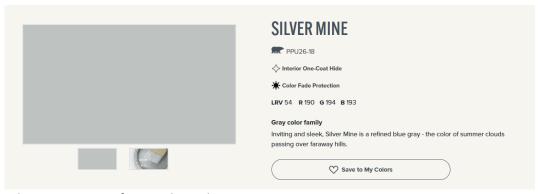
Silver Mine entry from Behr website

The applicant plans to repaint the entire garage with Behr's Silver Mine #PPU26-18.

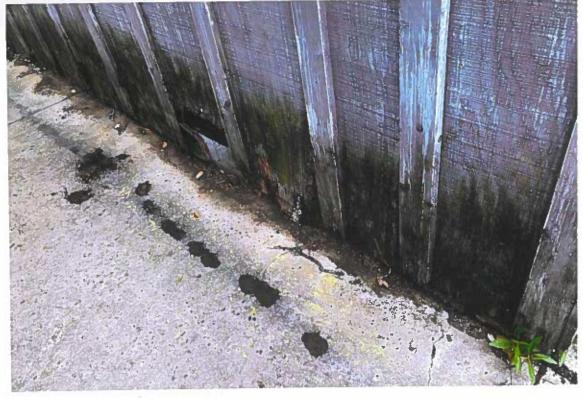
Current
Condition

Water damage on the garage at the base of the north wall has been noted on the owner's tax exemption inspection report for several years. The applicant says that the damage started low and has extended upward over the years, so she expects the problem is the result of moisture wicked up from contact with the ground rather than rainwater splashing off the concrete. The damage is confined to the siding and the studs are unaffected.

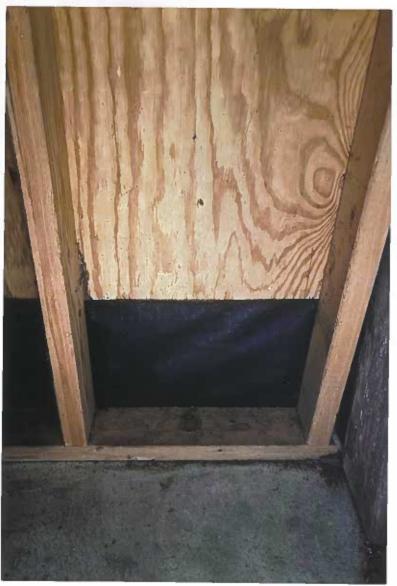
The Inside wall is not damaged
