Round Rock Stagecoach Inn

Round Rock, Texas

Relocation Feasibility Study

December 5, 2016

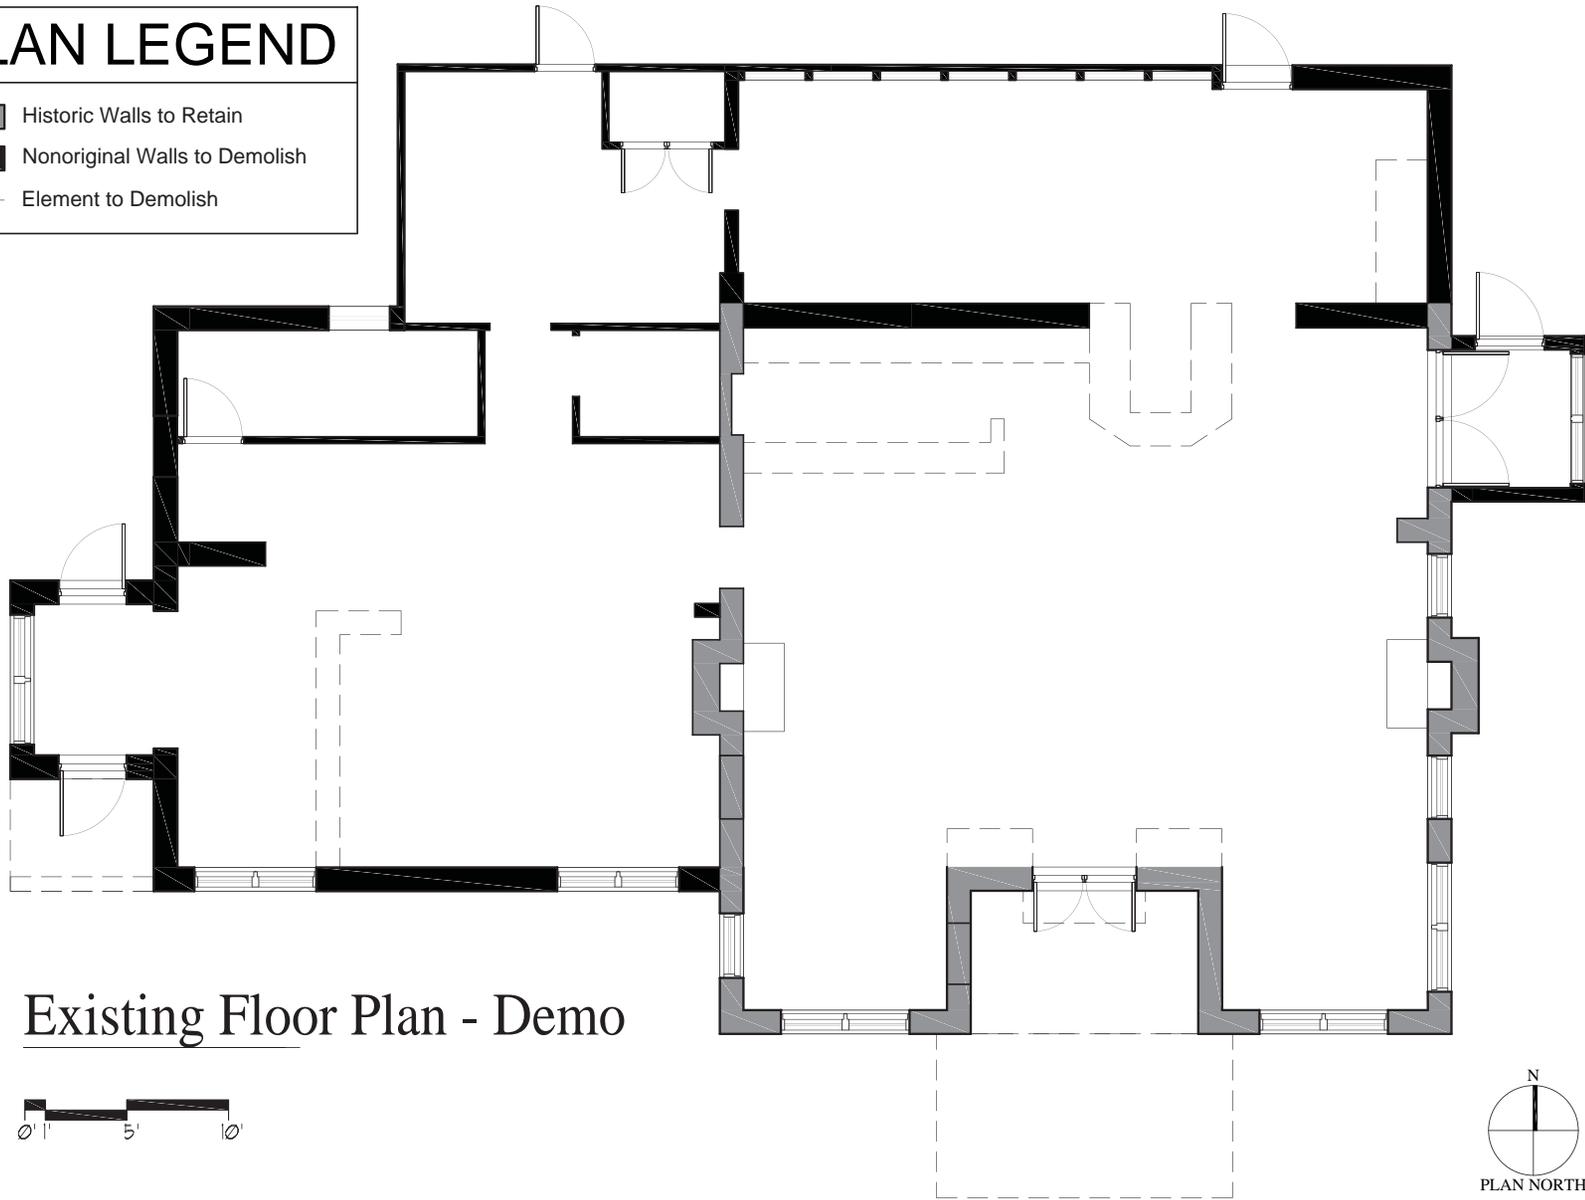
Existing Floor Plan - Demo

Figure 19. Floor Plan of Existing Structure, noting demolition
(Drawing by ARCHITEXAS, 2016)

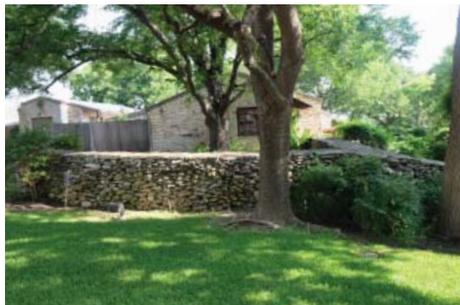
Stacked rock wall at south side

Depending on the new location, the dry stacked wall could be salvaged and reassembled at the discretion of the City of Round Rock. The pavers are set in a bed of concrete and will not be practical to relocate.

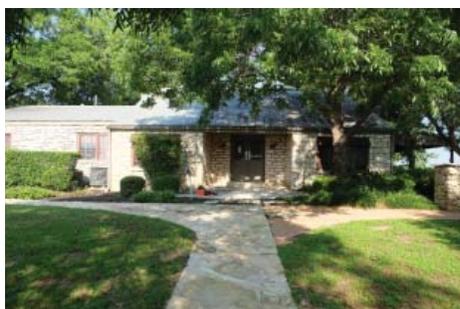
Vegetation and mature trees at east side

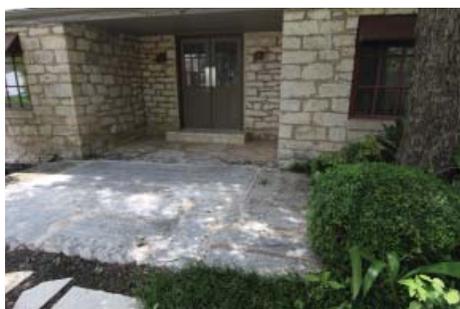
The large stones in front of the east door should be salvaged and moved with the building. Historic photographs show a stone platform in front of this entry and the size of the stones and the large size of the stones indicate that they may be historic.

Large stones at entryway of east side

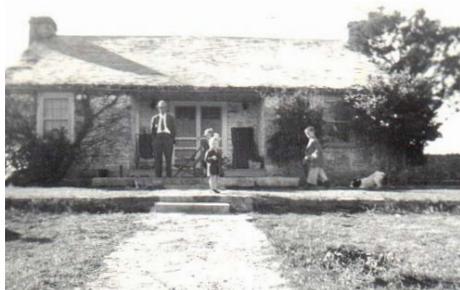
Historic photograph showing stone porch at east side

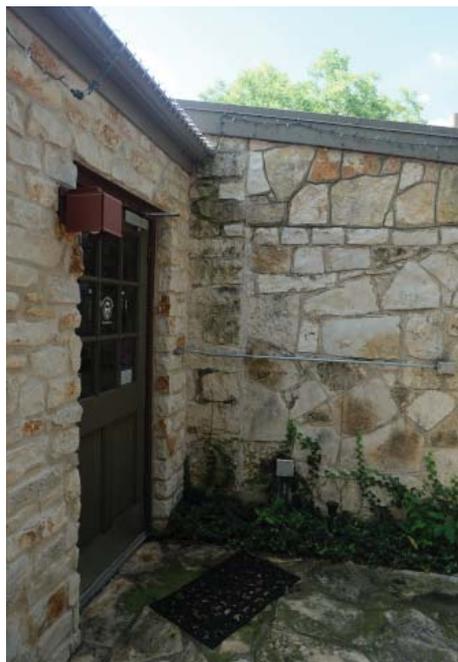
Change in stone from historic building (left) to new addition (right) at north side

The original limestone walls appear to be in good condition. The mortar varies in color and is generally spread over the face of the limestone blocks at the mortar joints.

The limestone on the additions should be surveyed and evaluated to determine if any was repurposed from demolished historical exterior walls. Any new limestone from the additions should be demolished. It is recommended that a qualified architectural conservator conduct mortar analysis to determine the color and composition of the original mortar for repointing. Generally, a type N mortar is appropriate for exterior limestone.

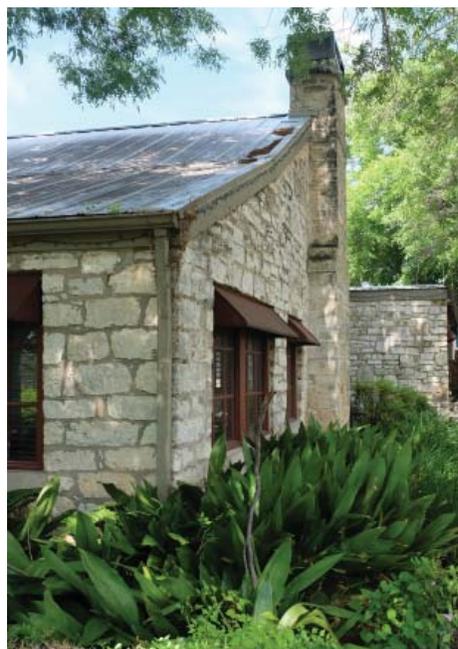
Painted gutters and downspouts at northeast corner

The roof and drainage system are currently in good condition.

Ultimately, it is recommended that the roof over the historic structure be replaced with a wood shingle roof. The metal roof on the additions should be demolished with the additions. The main metal roof can remain on the historic building during relocation.

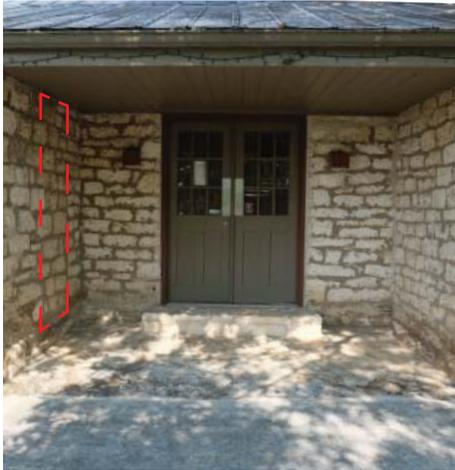
Original door opening with modern doors at east elevation; Dotted red outline of possible historic door at left

The existing doors are on good condition. Historic photographs show single doors at the west and south sides of the building. These doors were removed when additions were added. There is an outline in the masonry of a single door opening to the south of the main doors.

It is recommended that all of the door openings be restored when the building is stabilized after relocation. The new doors should be historically appropriate. In historic photographs, it appears that there may have been screen doors; although the historic doors are difficult to clearly see in photographs. The outlined door opening south of the entryway may be interpreted as historic and reconstructed.

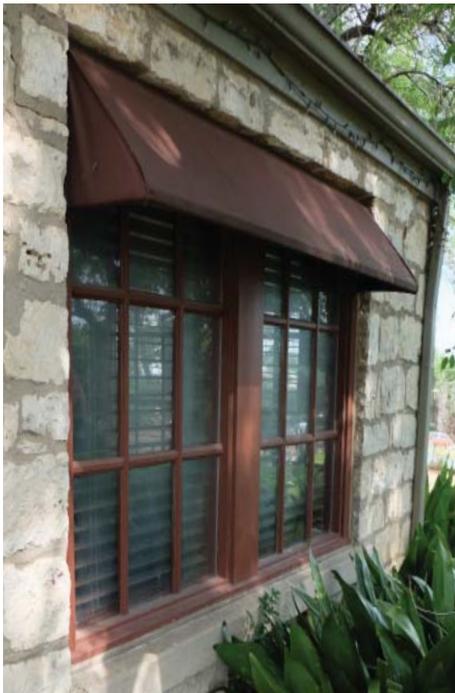
New double casement windows

The windows are in good condition. Although some of the new window openings are in the same place as the original, none of the windows or the size of the window openings are original. There is evidence of an infilled window opening on the interior of the historic south wall.

From historic photographs, it appears that originally there were ten (10) wood six-over-six windows approximately 2'-4" wide by 3'-4" high (see Historic Floor Plans on page 46). It is recommended that the historic windows be reconstructed for the building during the full rehabilitation. Initially after the relocation, original window openings should be reinstated when walls are reconstructed. Temporary exterior grade plywood can cover the openings until resources are available for new windows. The existing windows can remain until the full rehabilitation.
