100 E. Main Street
Certificate of Appropriateness HP24-000017

About the building:

The Old Broom Factory is a limestone two-part arcaded commercial block with a stepped parapet, built in 1880. It is a contributing structure in the National Register Round Rock Commercial Historic District and a Recorded Texas Historic Landmark.

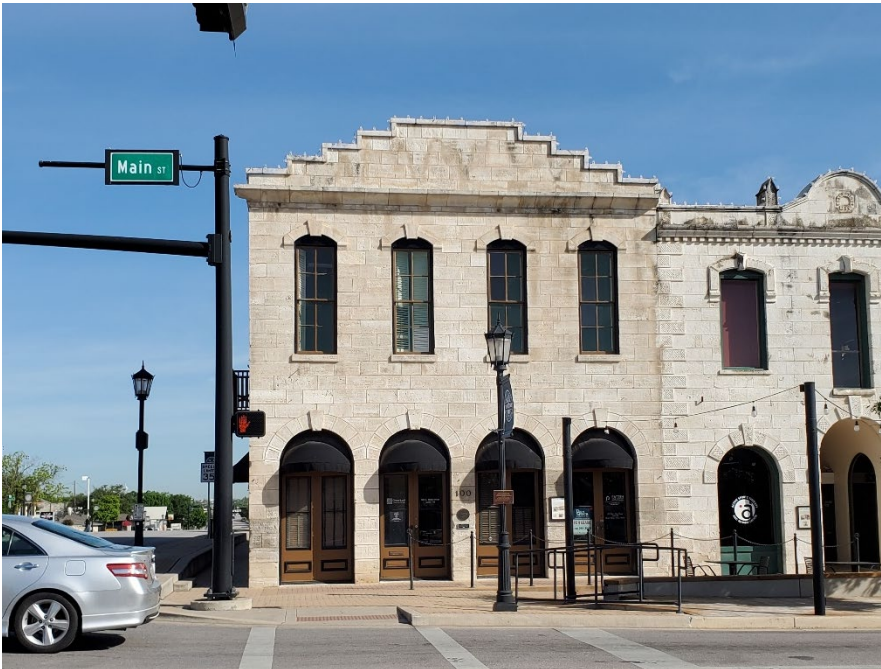
2024 photo, south (front) side

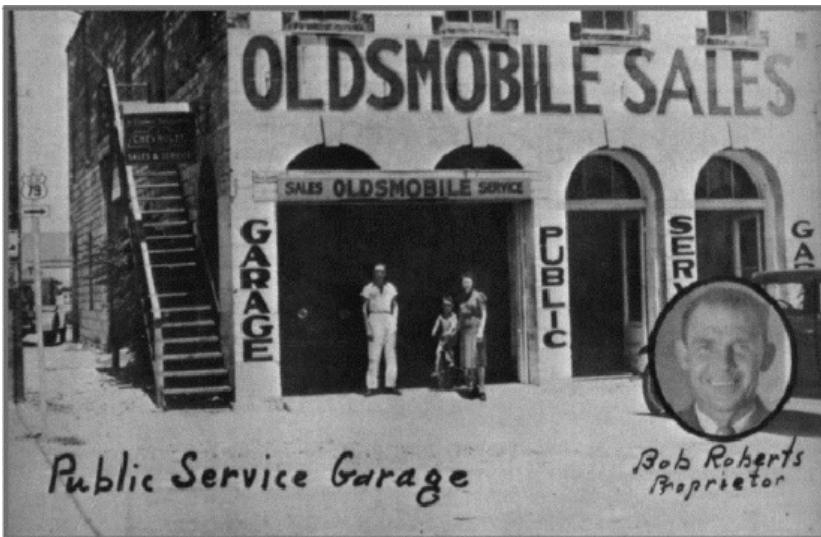
1938 photo showing alterations for vehicle access

When the building was rehabilitated in 1982 the front column was restored, the west vehicle opening was filled in with four double-hung windows, and the north vehicle opening was filled in with three divided-lite doors. A metal shed built against the back of the building that had housed The Tap bar was removed. A staircase on the west side was removed as it was too close to Mays Street/US 81 and a 2-story wooden porch with stairs was built on the north (back) wall.

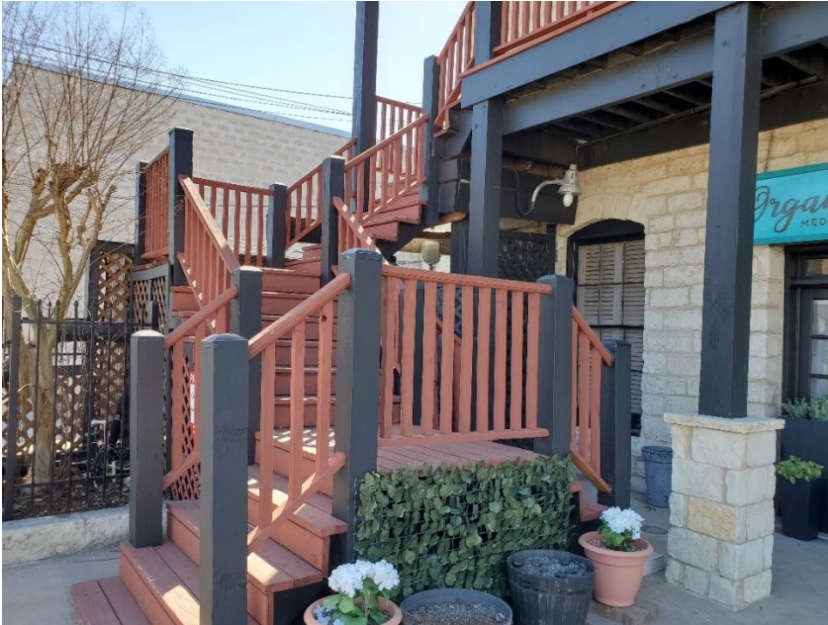
The previous back staircase was built in 1982 and is not considered to have attained its own historic significance. Previously the staircase had three landings and steps descending from the lowest landing both north and south. A back staircase is required by fire code to provide a second egress from the second floor.

Previous back staircase (2022 photo)

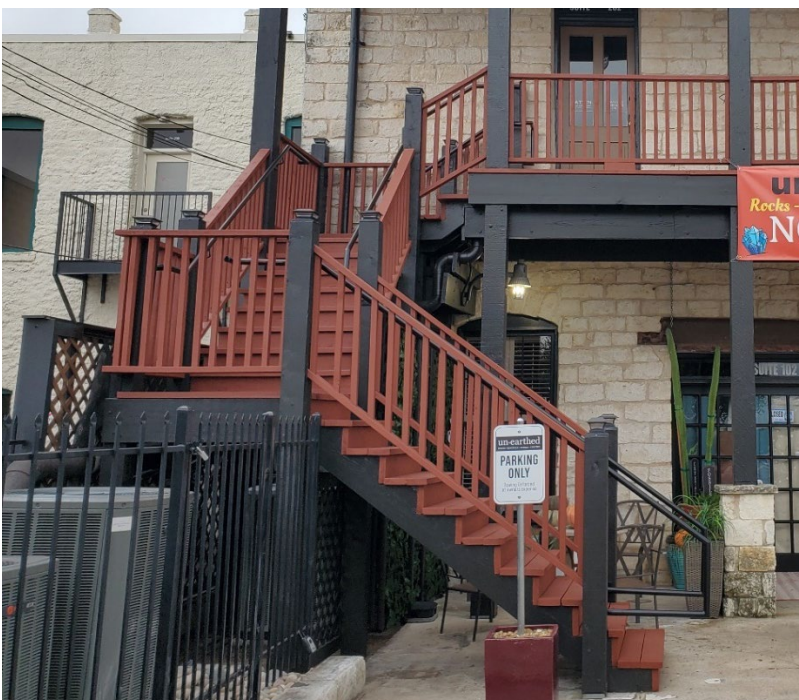
The new back staircase eliminates the lowest landing, and a single flight continues west to grade level. The new staircase has the same type of construction with the same forms for posts, decking and railing. A new metal handrail and solar downlighting on the posts have also been added.

New back staircase (November 2024)

Standard for Rehabilitation #9 states that new additions to a should be compatible with the historic structure, and the Guidelines for new exterior additions recommend that new features should have a simple design and be secondary features to the historic structure. Staff agrees that the stair design meets this standard and that the new stair configuration is at least as appropriate for the building than the previous configuration. The THC also determined that the reconfigured stair is appropriate.

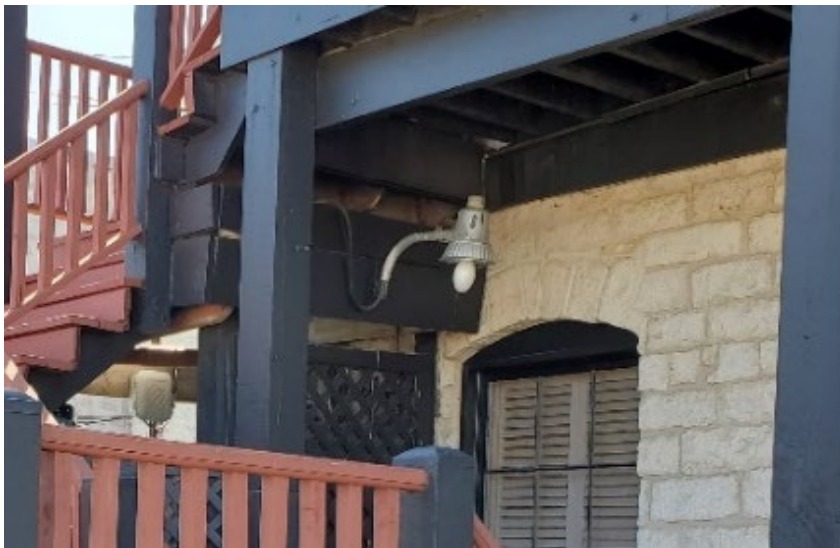
Current light fixture (2022 photo)

The applicant wishes to replace the light fixture under the staircase with one that is more period-appropriate. The application does not name a specific model for the new fixture but the photo in the plans show a black or dark bronze gooseneck light.

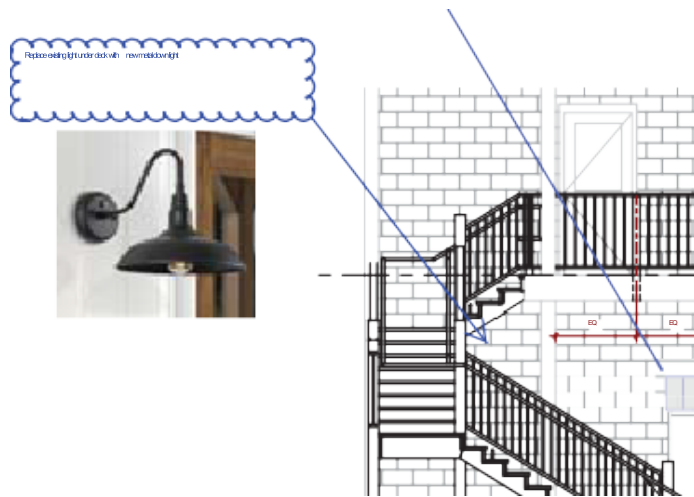
Proposed light fixture

The THC agreed that the proposed fixture design is more appropriate but cautioned against installing one that was attached to the stone wall of the building. Staff believes the illustrated fixture is appropriate but would like to have the product number and specific location. Staff agrees that the fixture should be attached to the staircase rather than the stone wall.

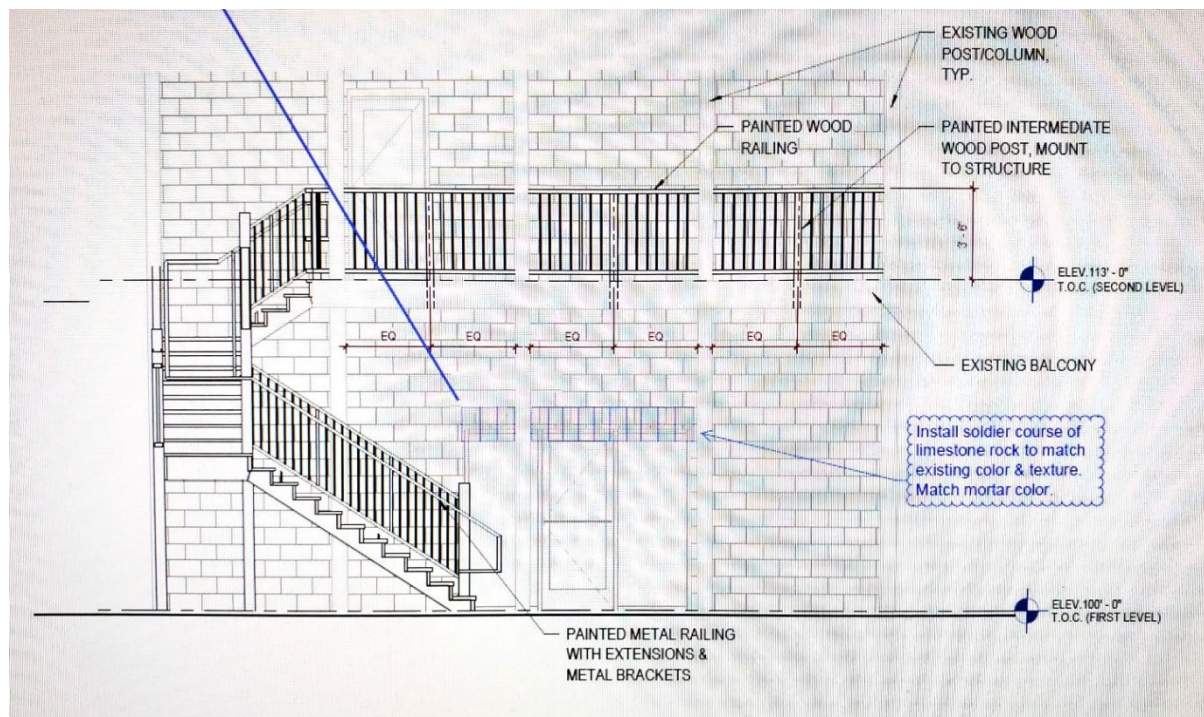
The fourth request is to cover a steel I-beam lintel in the north (back) wall with a soldier course of limestone veneer matching the color and texture of the stones in the wall. These stones would be hand-cut with chisel marks similar to the historic stone.

Detail from application

The THC determined that based on Standard for Rehabilitation #2, adding a soldier course of limestone veneer over the lintel would create a false sense of development. They denied the request, recommending that the lintel remain exposed as evidence of the period when the vehicle entrances were added. The applicant has noted the tenants do not like the rusty appearance of the lintel.

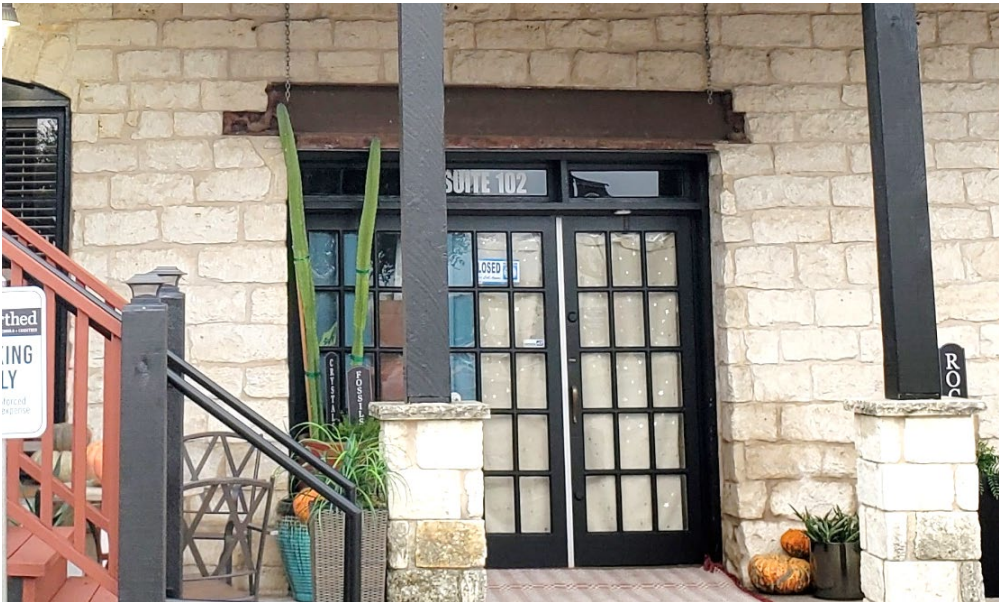
Photo of back entrance, November 2024

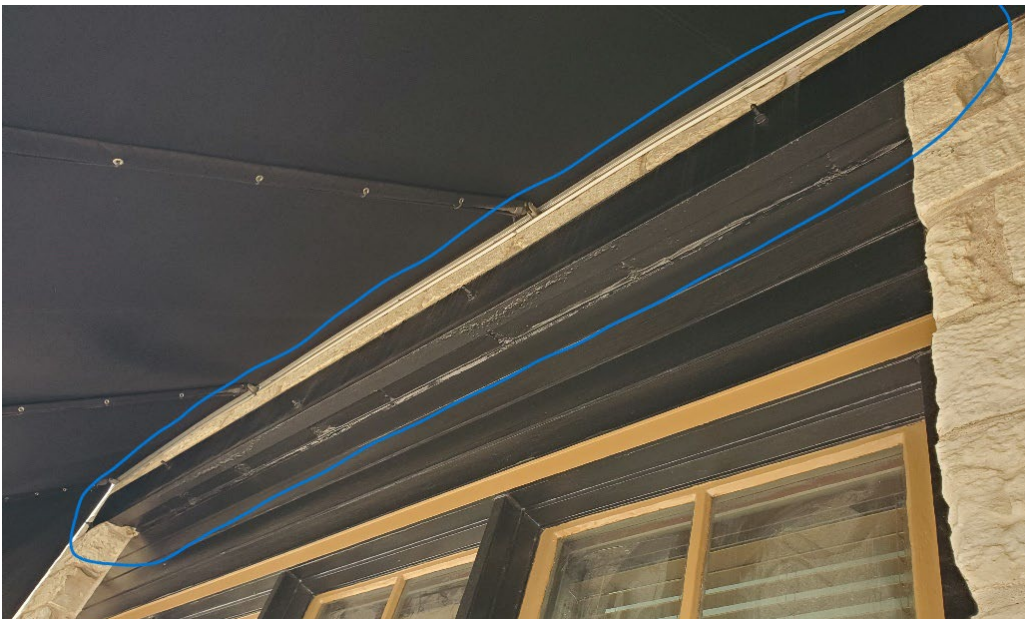
Staff notes that the other remaining vehicle opening on the west side is spanned with a different type of lintel made from steel plate and bolted to the wall over the opening. In the 1938 photo, the lintel on the south side appears to be the plate type, and it's likely that all three openings originally had this type of lintel. If so, the I-beam lintel on the back wall would have been installed later, perhaps in 1982 when the back porch and staircase were built. However, the significance of the different lintel types remains speculative until additional documentation is produced.

Photo of west lintel under awning, November 2024

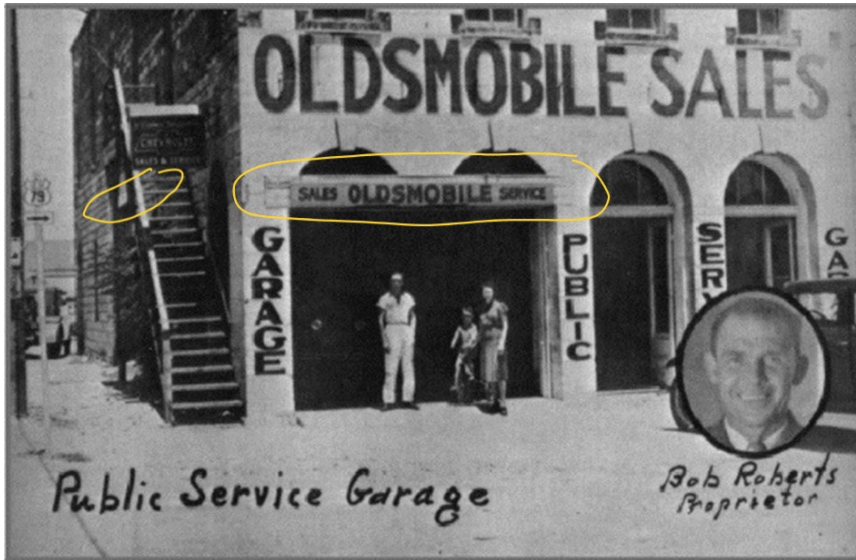
1938 photo indicating lintels

It's possible that the different lintel types reflect different eras of the building's history, and it's also possible that the era embodied in the I-beam lintel is as significant as the era evidenced by the steel plate lintel. Staff attempted to contact the architect who managed the 1982 rehabilitation but was unsuccessful. Until the different lintel types is explained staff also recommends against covering the I-beam lintel on the back wall.
