December 6, 2023

City of Round Rock

**Re: CCBP Eagles Nest 3 - SDP2208-0002 – Sunrise Rd. at Eagles Nest St.
Monarch Tree Removal Request**

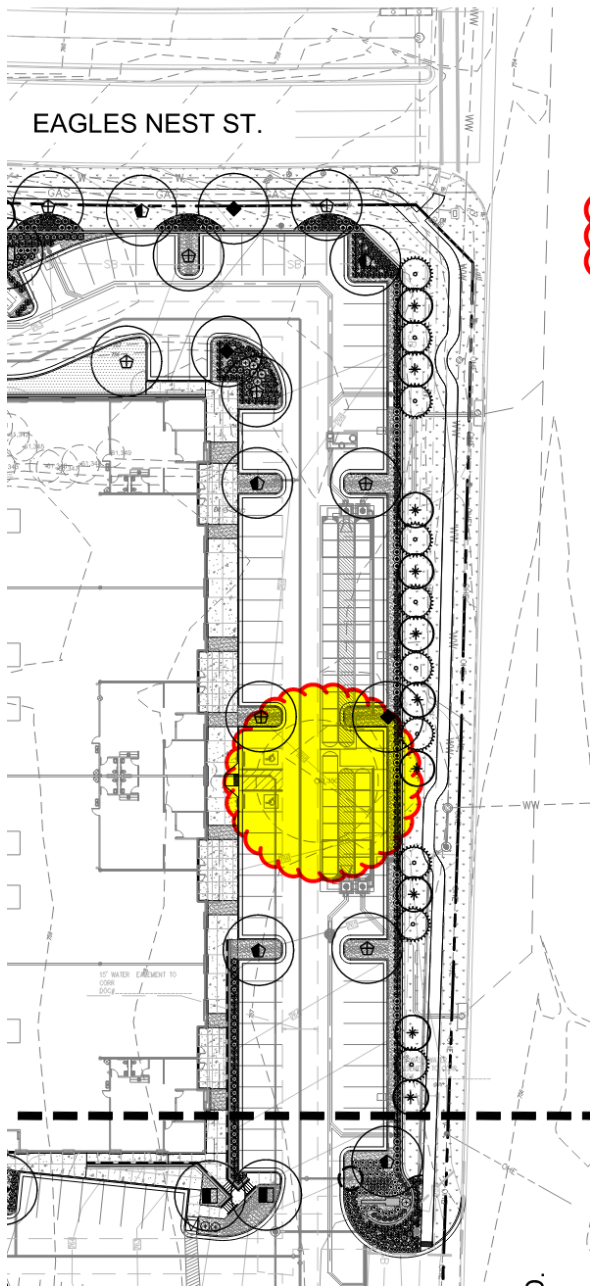
Site Plan Screenshot:

The existing grade of the tree is 758 and the proposed grade at this location is 766, a delta of +8' of fill.

- In the vicinity of the tree, the site requires earthen fill up to 8'. The fill is required to satisfy grading requirements to meet the drainage design which was driven by existing topographic conditions, required site planimetries, and Engineering code requirements.

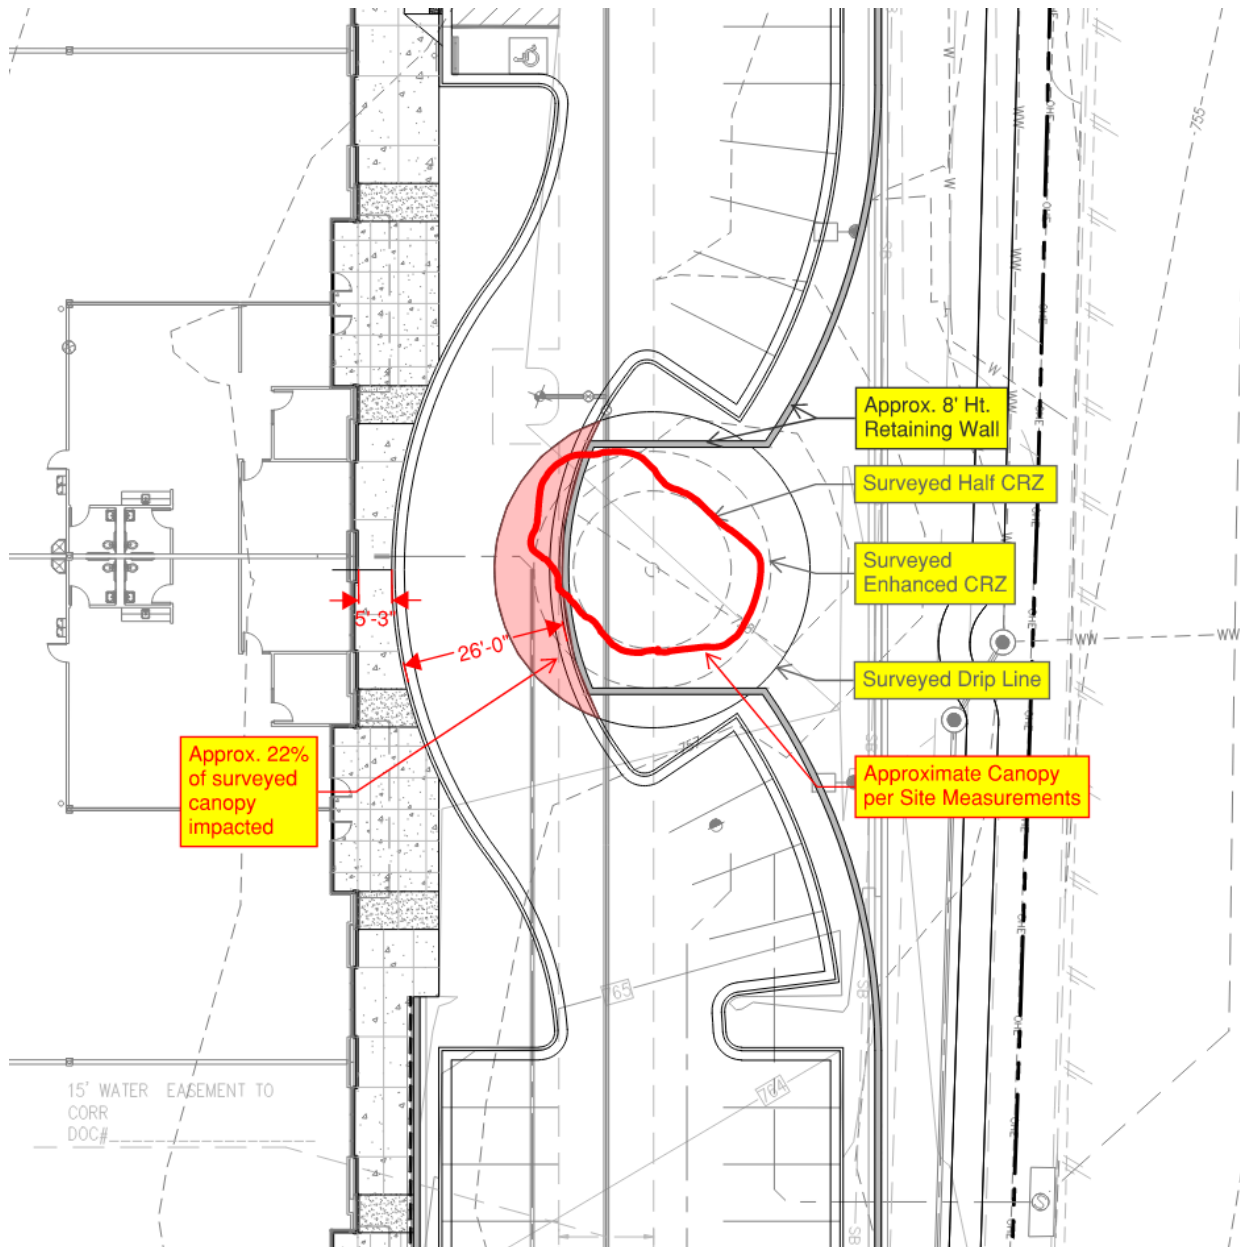
Site Plan Study:

- The study of shifting the drive aisle in between the building and required addition of an 8' wall that creates a well around the tree is not a workable solution. It results in a loss of 20 parking spaces, creates a barrier of entry and blockage at tenant entry points into the building, and an overall hazard for those tenants, pedestrians and cars required to navigate the thru drive aisle. The tree canopy also limits visibility into the site which negatively impacts tenant safety.
- A 26'-0" wide driveway was considered to not create an issue for fire truck circulation for the site overall and to allow for additional parking opportunities.
- This scenario impacts roughly 22% of the canopy and would require impact to the enhanced CRZ but would remain outside of the 50% CRZ.
