HISTORY/REQUEST: Certificate of Appropriateness (CofA) for roof, screen removal and new ADA ramp at 400 E. Main Street. House is to be converted from residential use to retail and office.

DATE OF REVIEW: October 19, 2021

"Dr. D.B. Gregg House" built 1930. Dr. Dick Bolling Gregg was Round Rock's only physician from the late 1920s to the 1960s. Minimal Traditional with Craftsman and Colonial Revival influences. H overlay zoning with MU-2 base zoning.

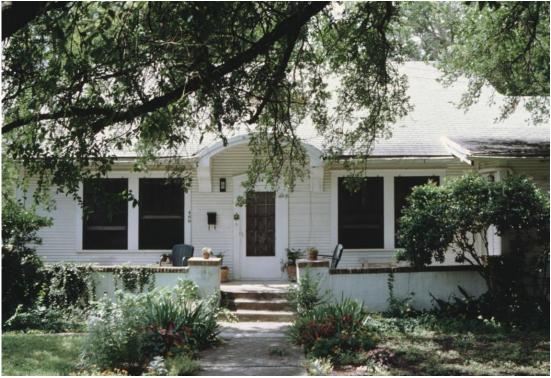
400 E. Main ca. late 1980s with gray composition shingles

The new owner wishes to replace the current gray-green composition shingle roofing with Owens-Corning Oakridge "Onyx Black" 3-tab composition shingles. Photos indicate that previous roofing has been asphalt or composition shingle of various colors and shapes. The original roofing material is not known but is presumed to be either wood or asphalt shingle.

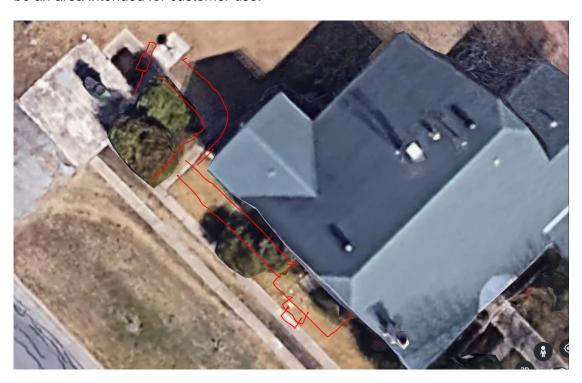
The applicant proposes adding a ramp to the north side of the west porch because of the proximity to a concrete pad at the rear of the property to be used for accessible parking. He prefers to use the side porch rather than the rear screened porch because the rear porch accesses the kitchen, which will not be an area intended for customer use.

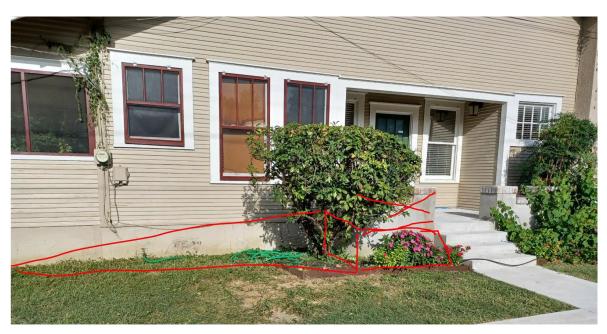
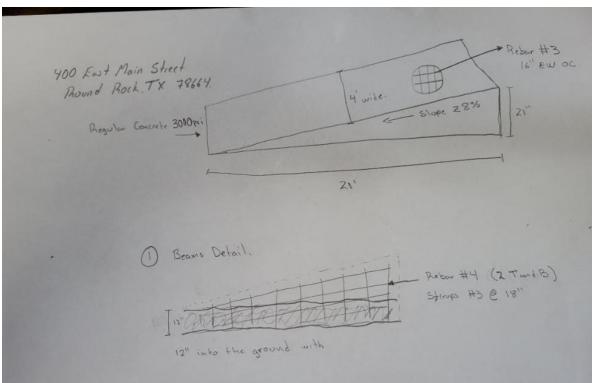
The proposed ramp is described as being made of concrete with a simple pipe railing. The ramp would be 21 ft long, so it would end about halfway along the screen porch in back. Drawings appear to indicate that the porch wall would be removed to the left side of the steps and remain on the right side. A few inches gap would be left between the ramp and the foundation skirting. A simple pipe railing would be located on the street side of the ramp but not next to the house.

Staff also notes some potential problems with leaving a space between the ramp and the foundation skirting: wheels could slip into the gap and pulling weeds would be difficult. Since the skirting on this part of the house is stucco-textured fiber cement siding, it is not a historic feature and would not be compromised by being attached to the ramp.

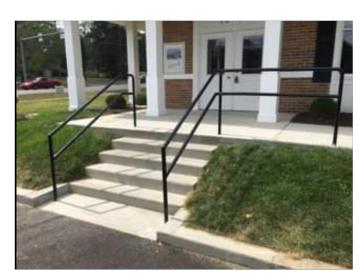
Applicant's examples of proposed pipe railing

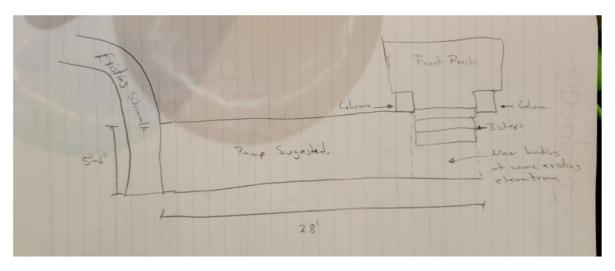
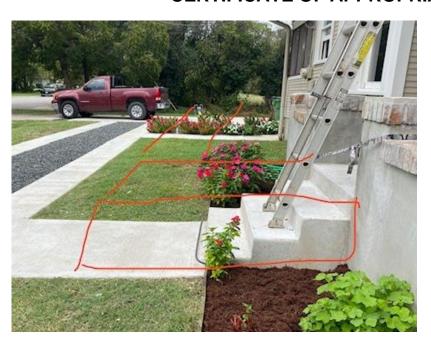
After determining that he couldn't cut through the corner block, the contractor offered a third proposal. This new proposal by the applicant was brought to staff the day before meeting packets were to be distributed to the HPC. In this proposal, the ramp would lead to a landing built over the existing steps in front of the porch. The diagram does not indicate whether this would be a ramp built over the existing steps, whether the steps would be replaced, or what the proposed material(s) would be.

Staff believes that not enough information about Proposal C has been provided to make a recommendation on it, but it may offer a more temporary solution if Proposal B is not feasible.
